Ford Grand C-MAX
Standard Safety Equipment

2017 ★★☆☆☆

Tested Model	Ford Grand C-MAX 1.5 diesel 'Titanium', LHD
Body Type	- 5 door MPV
Year Of Publication	2017
Kerb Weight	1606kg
VIN From Which Rating Applies	- WFOVXXGCEWHE77742
Class	Small MPV

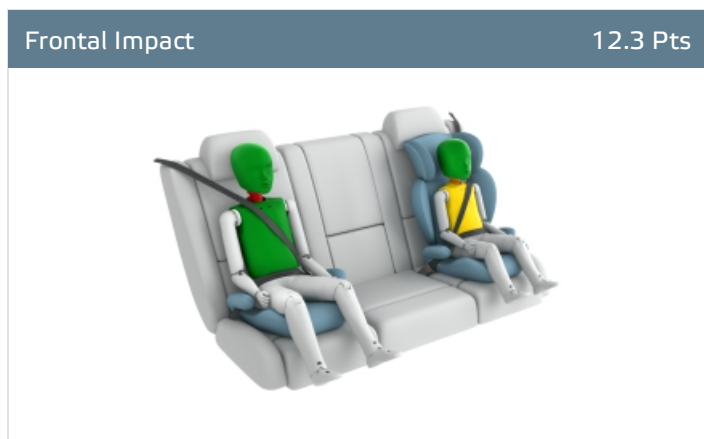
Crash Test Performance based on 6 & 10 year old children

20.3 Pts

Restraint for 6 year old child: *Römer KidFix XP*
 Restraint for 10 year old child: *Graco Booster*
 Safety Features

In the frontal offset test, readings of neck tension indicated poor protection of this part of the body for the 10-year dummy and marginal protection for the 6-year dummy. In the side barrier test, protection of all critical body areas was good. The front passenger airbag can be disabled in cars fitted with an optional cut-off switch, to allow a rearward-facing child restraint to be used in that seating position. As this switch is not standard equipment, no points are awarded in this assessment and the installation check of rearward-facing restraints is deemed a fail. ISOFIX and i-Size compatible anchorages are available only on the second row outboard seats.
