2020

Tested Model	SEAT Leon 1.5 petrol 'XCELLENCE', LHD
Body Type	- 5 door hatchback
Year Of Publication	2020
Kerb Weight	1294kg
VIN From Which Rating Applies	- VSSZZZKLZMR005539 including PHEV
Class	Small Family Car

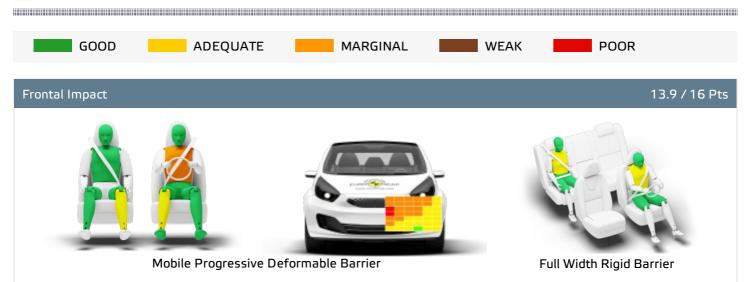
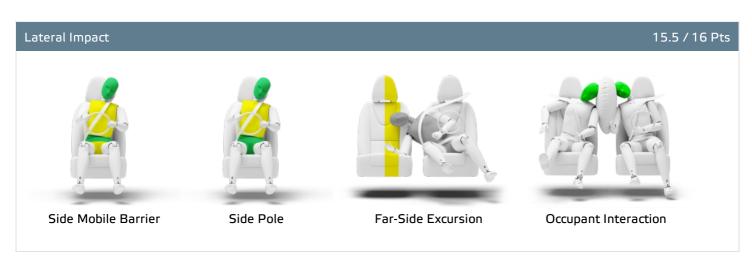
The passenger compartment remained stable in the offset frontal test. Protection of the driver's chest was rated as marginal, based on dummy measurements of compression. Dummy measurements indicated good protection of the knees and femurs of both the driver and passenger. SEAT showed that a similar level of protection would be provided to occupants of different sizes and to those sitting in different positions. Analysis of the barrier into which the Leon crashed showed some localised areas of high deformation and a modest penalty was applied to the score for the risk this represented to the opposing vehicle. In the full-width, rigid wall test, protection was good or adequate for all critical body regions for both the driver and the rear seat passenger. In the side barrier test, representing a collision by another vehicle, protection of all critical body areas was good or adequate for all critical body areas. Similarly, in the more severe side pole impact, protection was at least adequate. In an assessment of protection in far-side impact, dummy excursion (its movement towards the other side of the vehicle) was rated as adequate. The Leon is equipped with a centre airbag to protect against occupant-to-occupant interaction in side impacts. This system worked well in Euro NCAP's test, with good protection of the head for both front seat occupants. Tests on the front seats and head restraints demonstrated good protection against whiplash injury in the event of a rear-end collision. A geometric assessment of the rear seats also indicated good whiplash protection. The Leon is equipped as standard with a multi-collision braking system, which applies the brakes immediately after an impact to prevent the vehicle from being involved in secondary impacts. The car also has an advanced e-Call system which, in the event of an accident, automatically sends a message to the emergency services, giving the car's location.
