Volkswagen ID.5
Standard Safety Equipment

2021

Tested Model	Volkswagen ID.4, rear drive, LHD
Body Type	- 5 door SUV
Year Of Publication	2021
Kerb Weight	2029kg
VIN From Which Rating Applies	- all VW ID.5s
Class	Small Off-Road

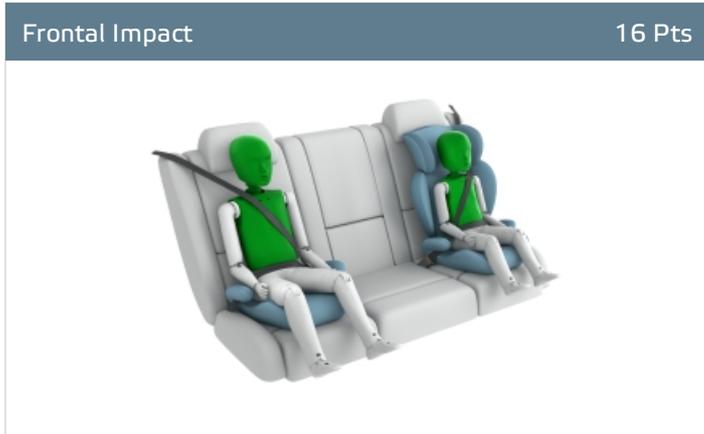
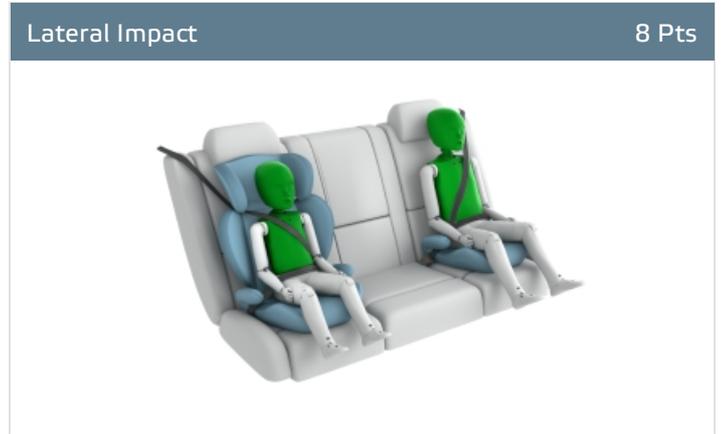
Crash Test Performance based on 6 & 10 year old children

Restraint for 6 year old child: *Britax Römer Kidfix*
 Restraint for 10 year old child: *Britax Römer Kidfix*

In both the frontal offset test and the side barrier test, good protection was provided to all critical body areas of both the 6 year and 10 year dummy, and maximum points were scored in this part of the assessment. The front passenger airbag can be disabled to allow a rearward-facing child restraint to be fitted in that seating position. Clear information is provided to the driver regarding the status of the airbag and the system was rewarded. All of the child restraint types for which the car is designed could be properly fitted and accommodated in the car.
