## Volkswagen Taigo

Standard Safety Equipment

2022

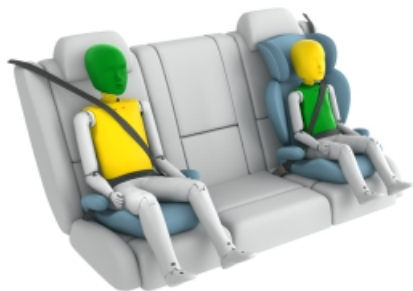
Frontal Impact

14.2 Pts

In the frontal offset test, dummy measurements indicated adequate protection of the neck and chest of the 10-year dummy, and adequate protection of the head and neck of the 6-year dummy. In the side barrier test, protection of the head of the 10-year dummy was rated as marginal, based on measured values of acceleration. The front passenger airbag can be disabled to allow a rearward-facing child restraint to be used in that seating position. Clear information is provided to the driver regarding the status of the airbag and the system was rewarded. All of the restraint types for the which the Taigo is designed could be properly installed and accommodated in the car.

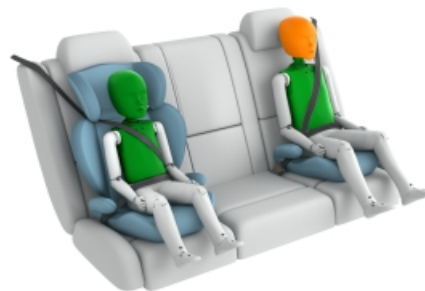
Lateral Impact

7 Pts

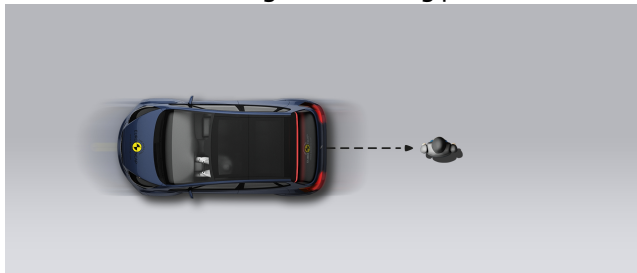
Vehicle reversing into standing pedestrian

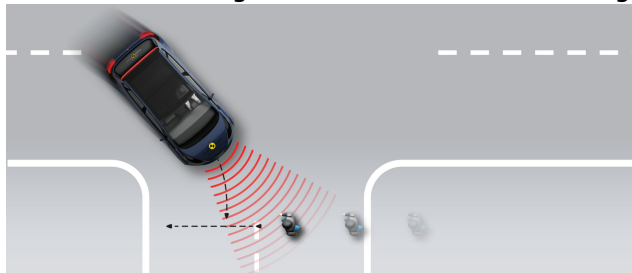
Pedestrian crossing a road into which a car is turning

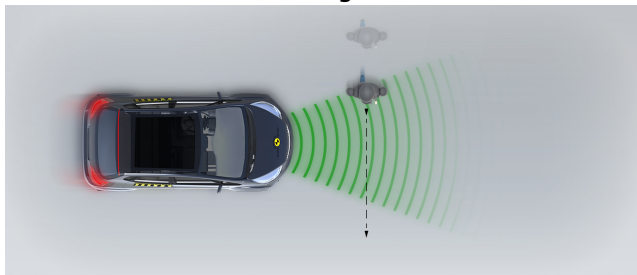
Adult crossing the road

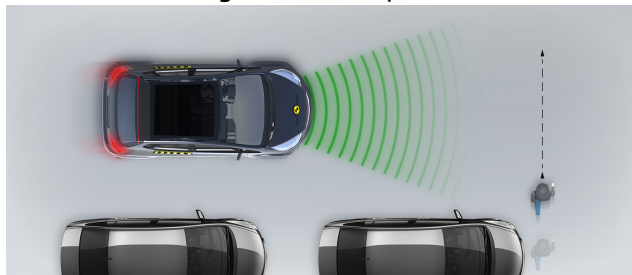
Child running from behind parked vehicles

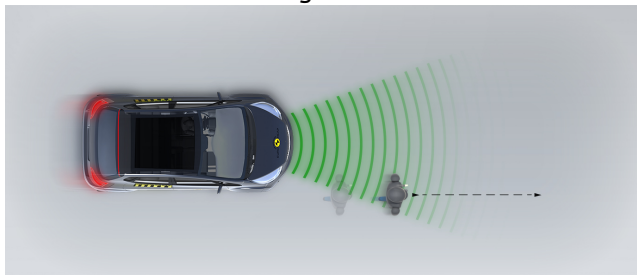
Adult along the roadside

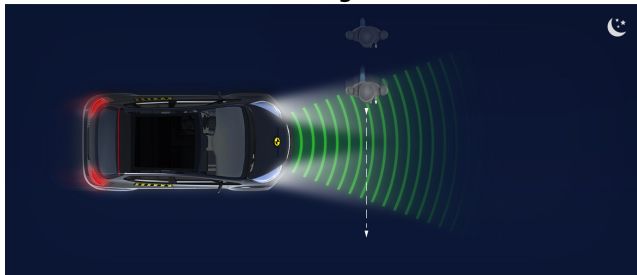
Adult crossing the road

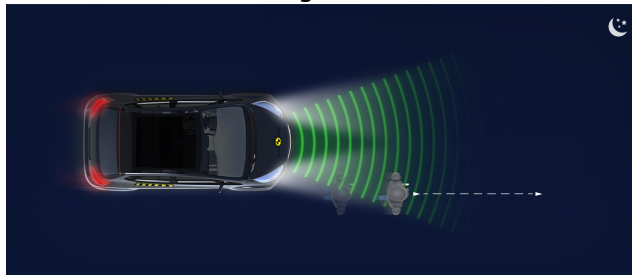
Adult along the roadside

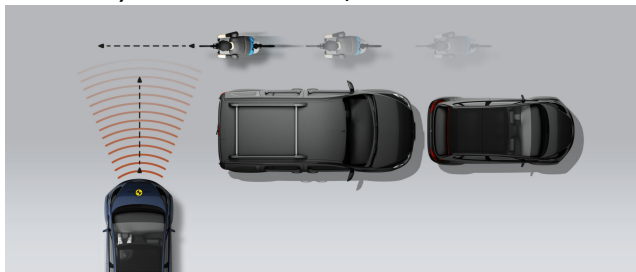
Cyclist from nearside, obstructed view

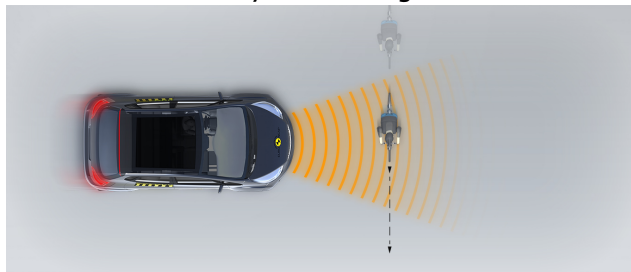
Cyclist crossing

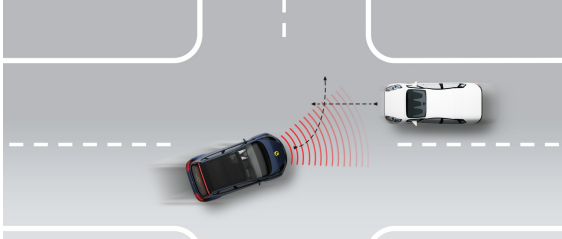
Test car turns across the path of an approaching car

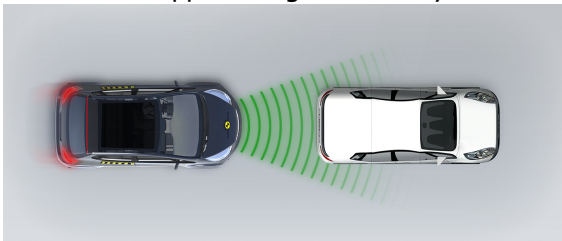
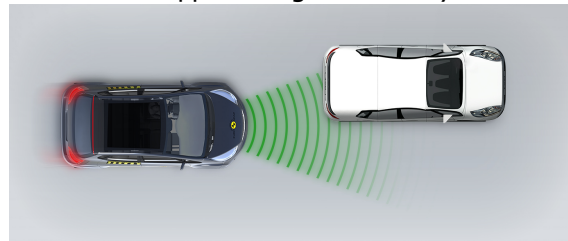
Approaching a stationary car

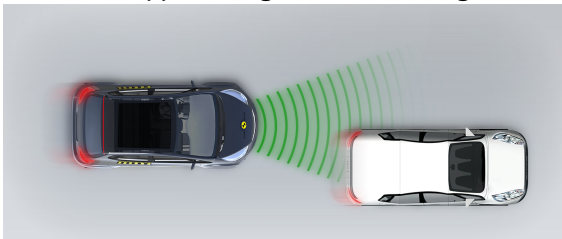
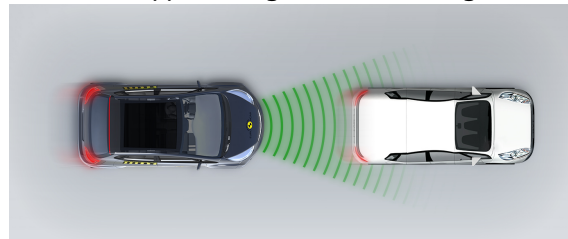
Approaching a slower moving car

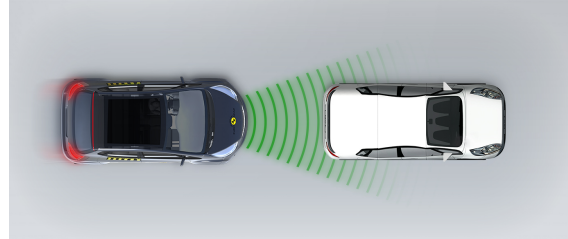
Approaching a stationary car

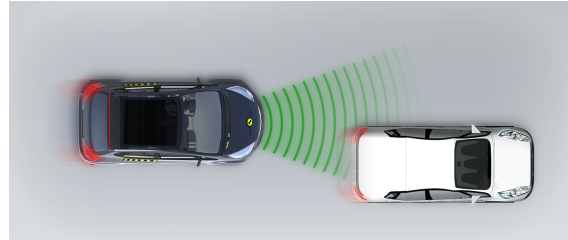
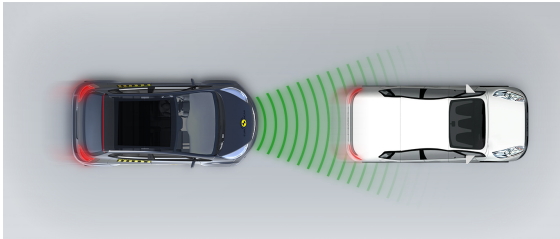
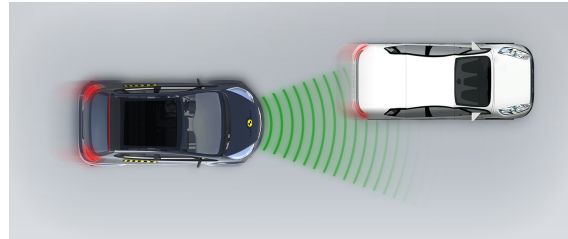
Approaching a slower moving car

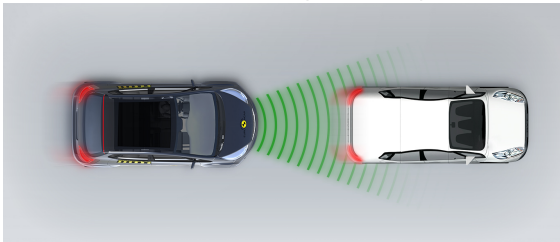
Approaching a braking car
